TRANSPORTATION RESEARCH CENTER

ON-SITE AIR BAG INVESTIGATION

CASE NO. - 93-07

The 1990 Dodge Daytona was equipped with a driver supplemental restraint system (air bag) which did not deploy as a result of the right front impact. The driver of the vehicle (28 year-old female) was not wearing the available, active, three-point, lap and shoulder belt. The driver was ejected out the backlight and was found just west of the Daytona's final rest position. She sustained fatal injuries including multiple lower left rib fractures and a massive hemothorax (i.e., estimated at between 2000-3000 ccs) which resulted in cardio-pulmonary arrest from exsanguination. The driver of the Daytona was listed on the Police Accident Report as sustaining a "K" (fatal) injury as a result of her crash. The driver (33 year-old male) of the Fiero was listed on the Police Accident Report as restrained and sustaining an "A" (incapacitating) injury.

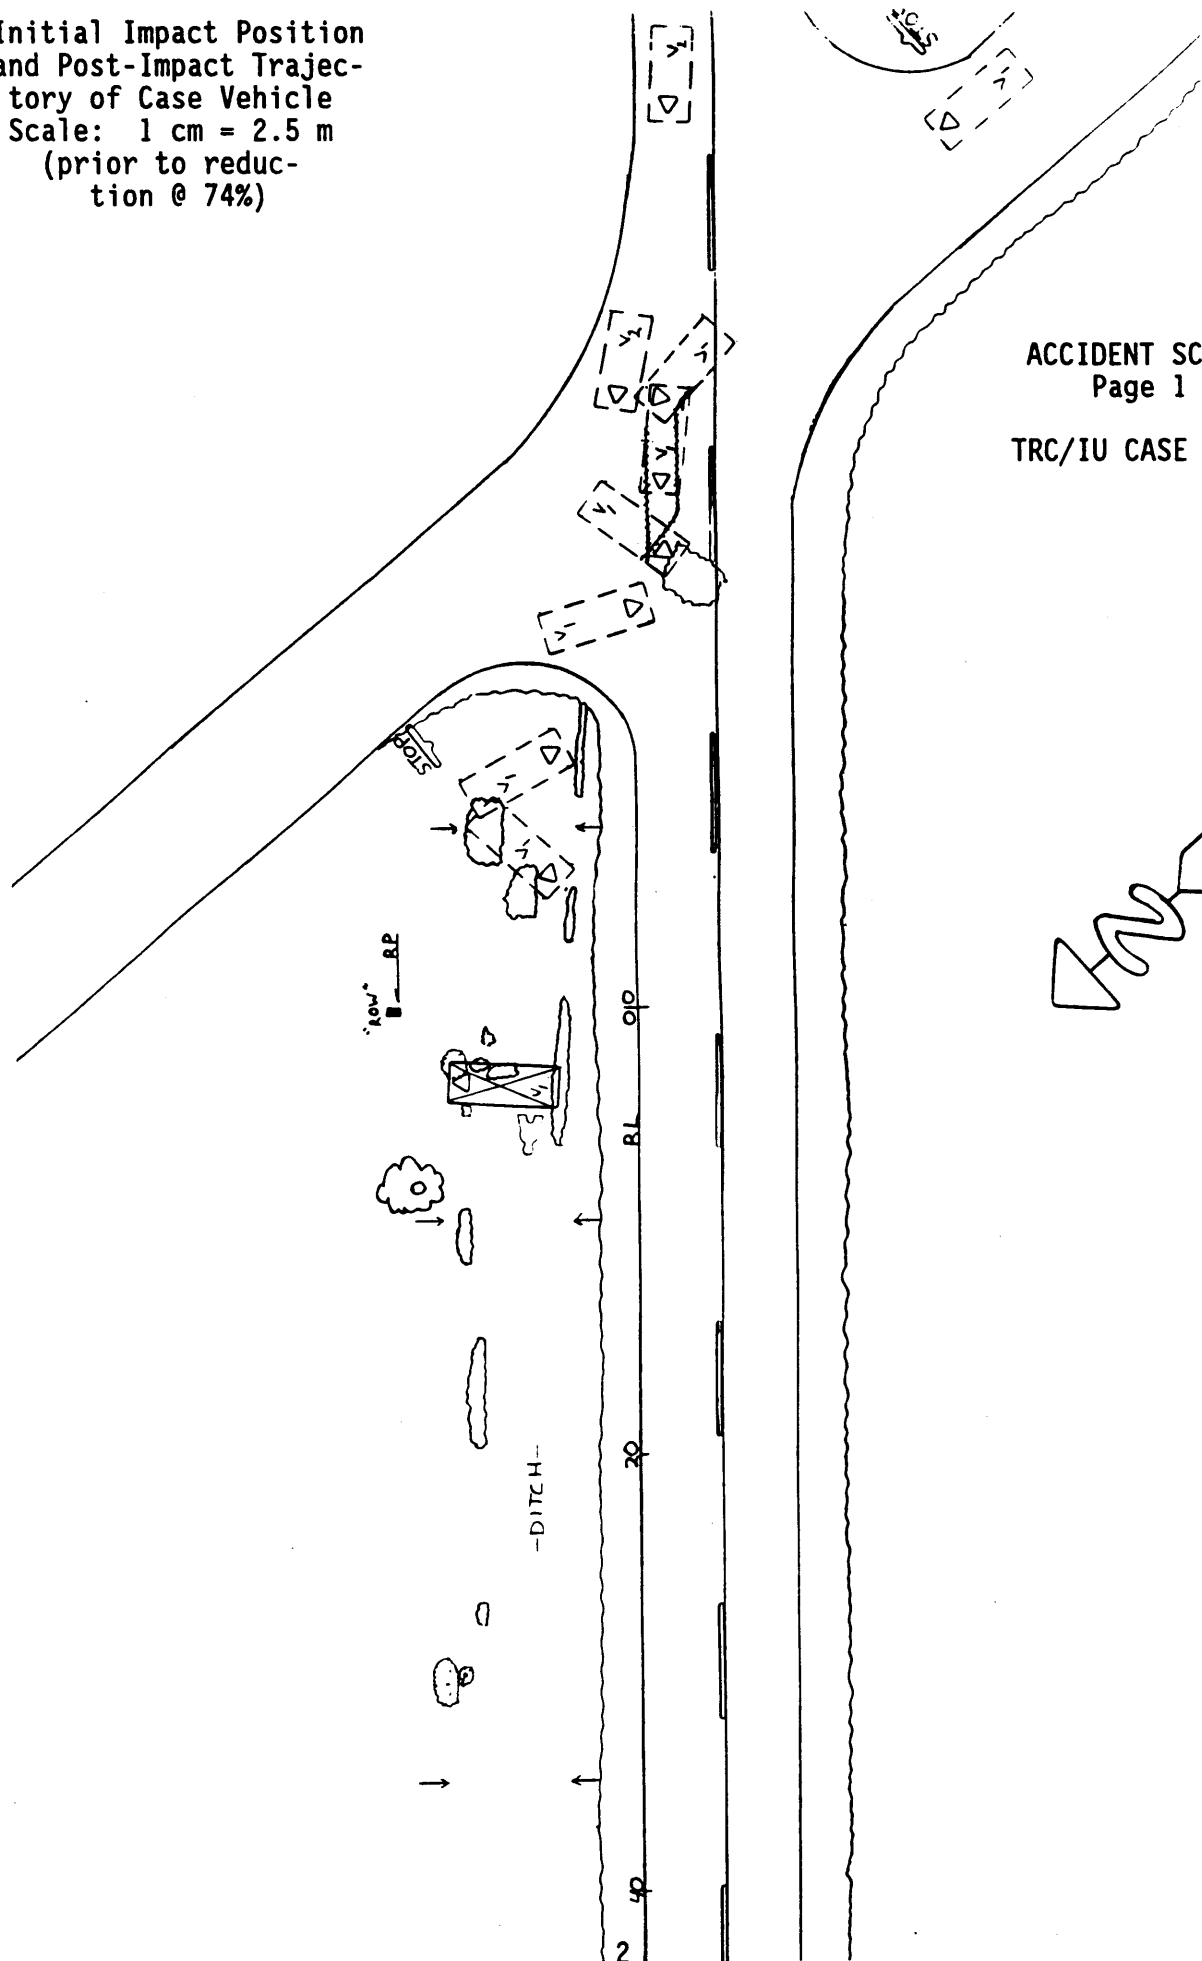
Initial Impact Position
and Post-Impact Trajectory
of Case Vehicle
Scale: 1 cm = 2.5 m
(prior to reduction @ 74%)

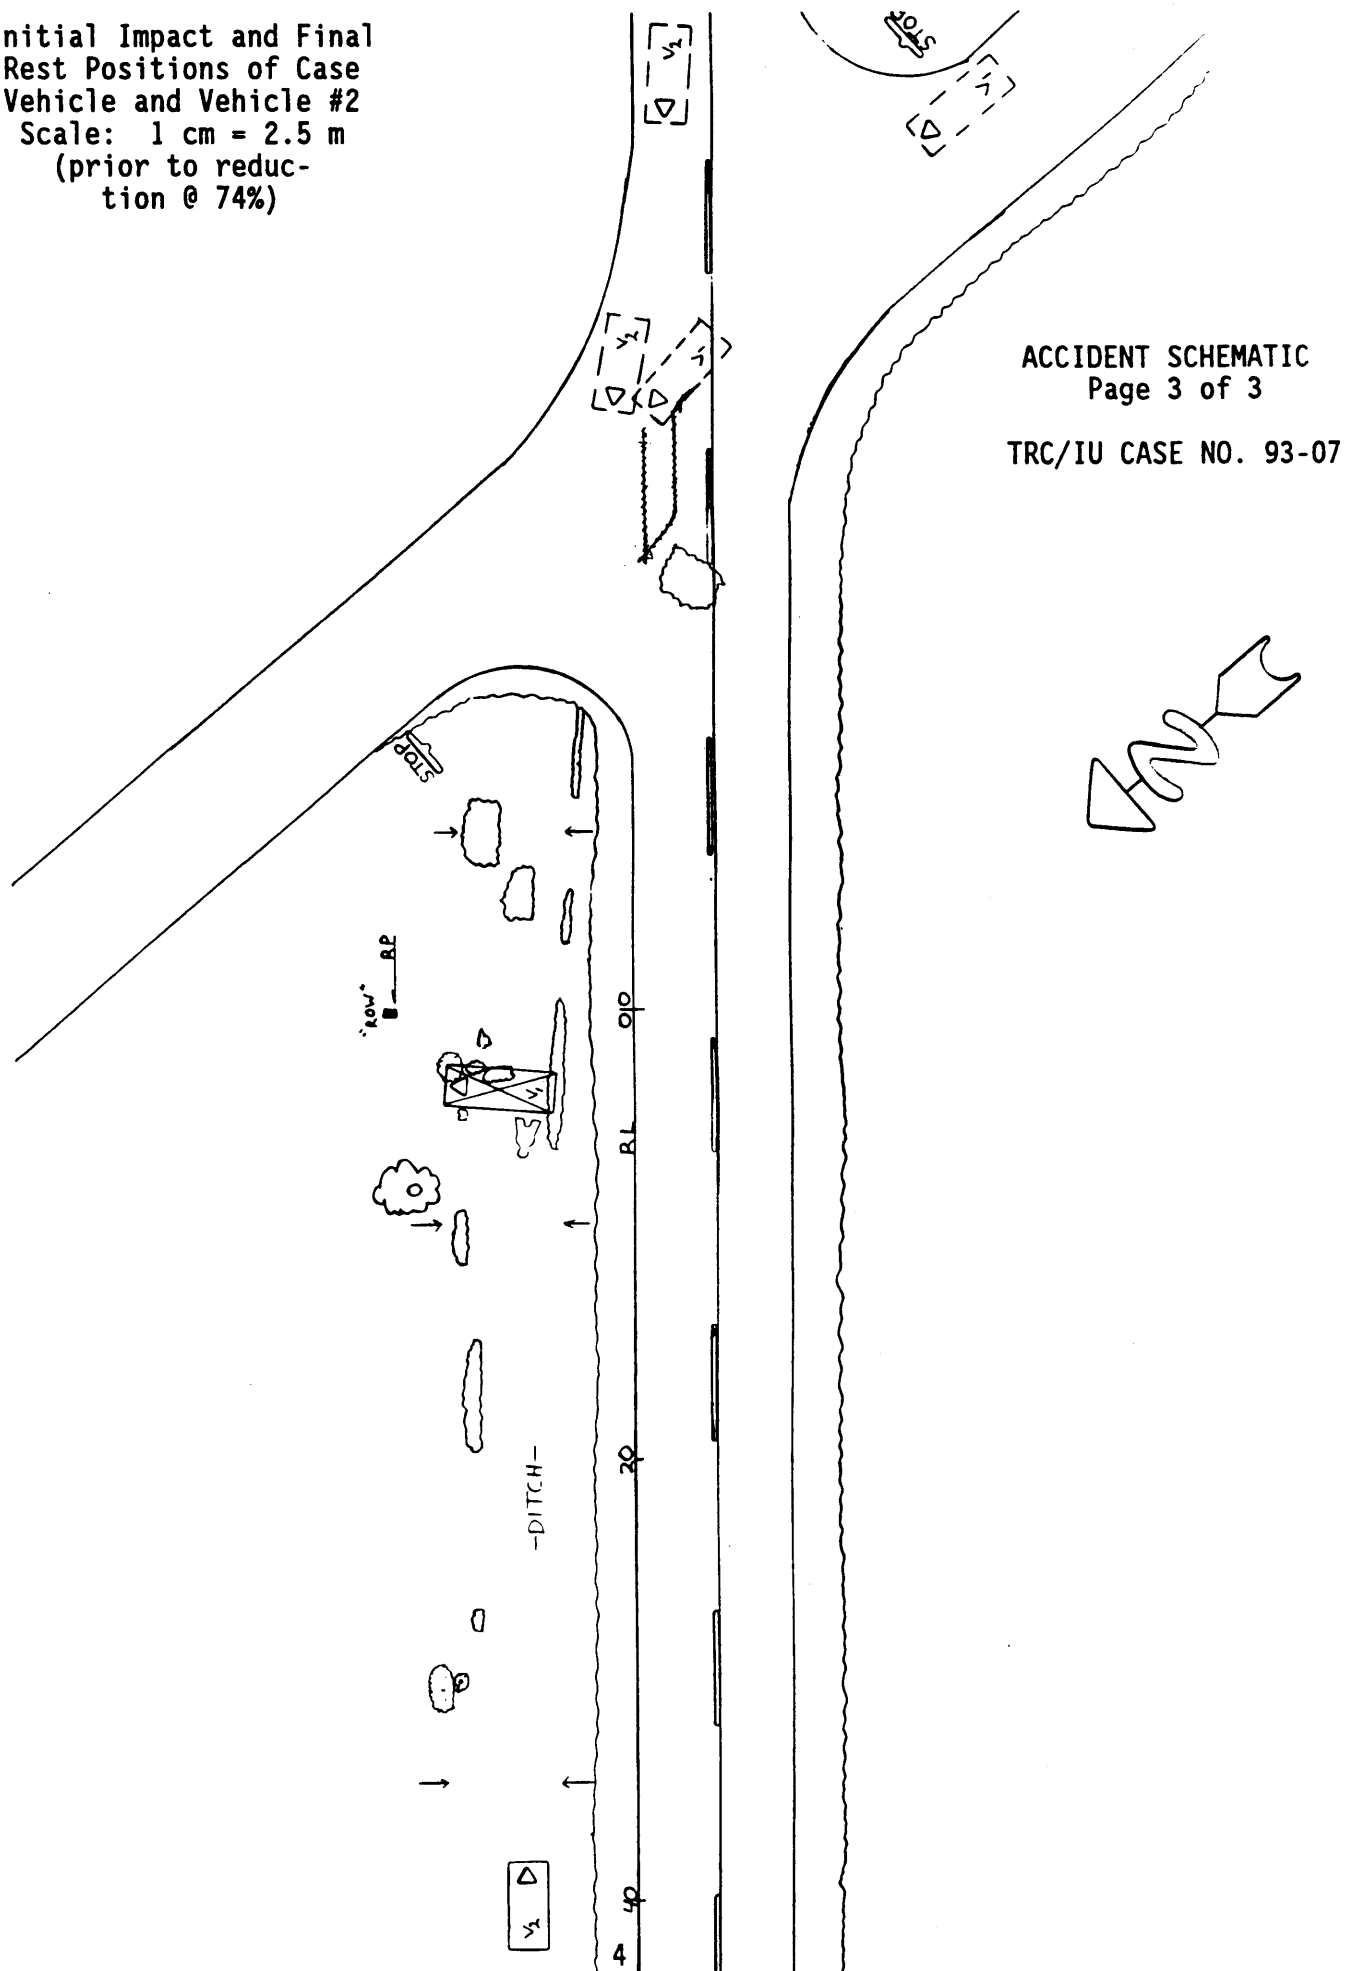
Initial Impact and Final
Rest Positions of Case
Vehicle and Vehicle #2
Scale: 1 cm = 2.5 m
(prior to reduc-
tion @ 74%)

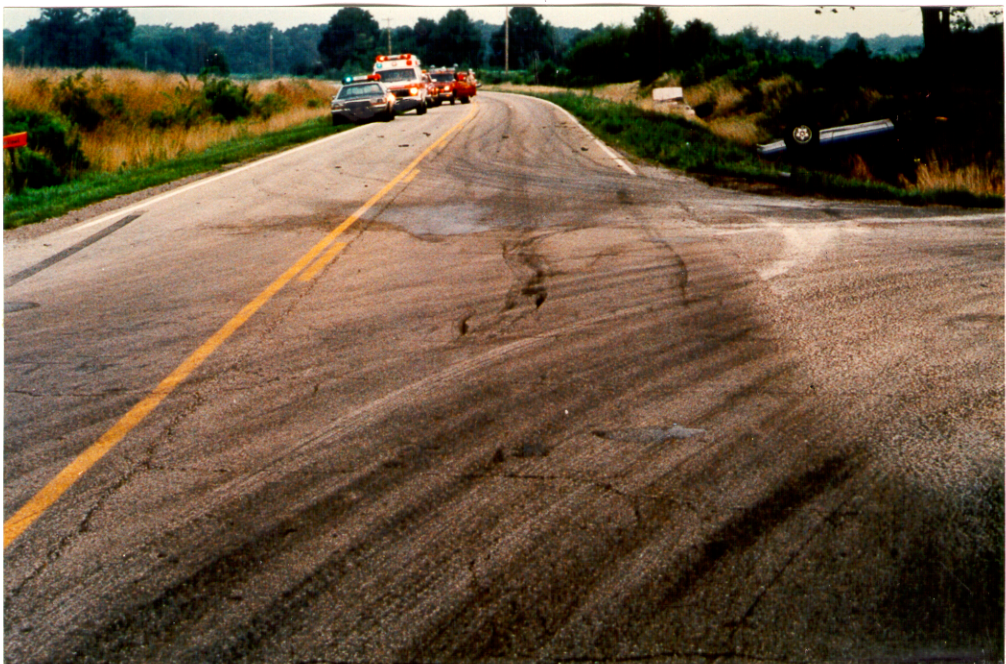
02 -- [REDACTED] 1993
 [REDACTED] Illinois
 TRC/IU: 93-07, Task: 0103
 ISP Photo: Fiero's westward
 approach to impact area

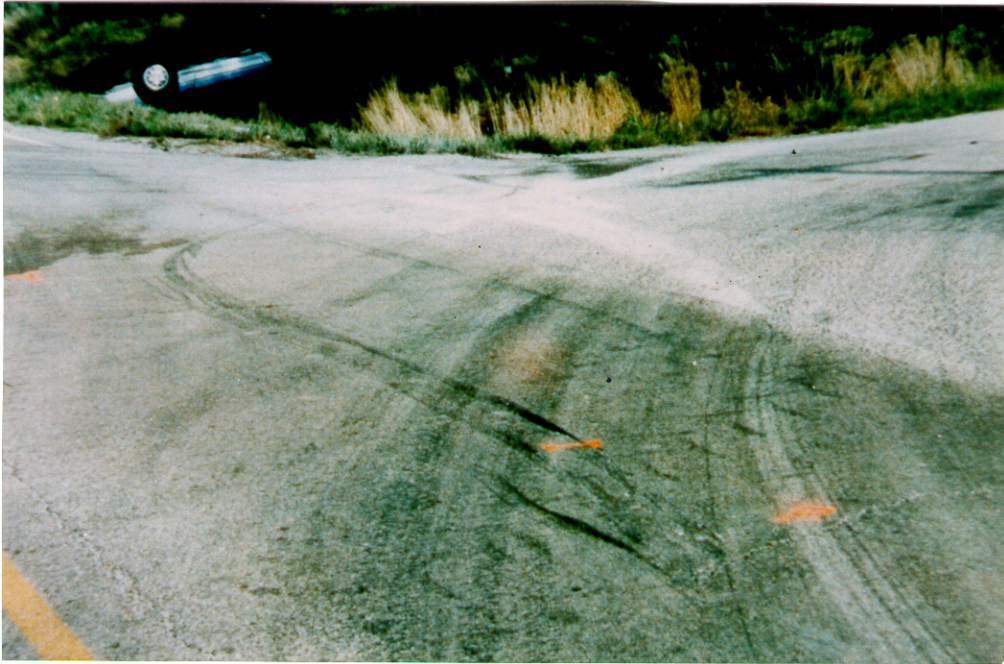
05 -- [REDACTED] 1993
 [REDACTED] Illinois
 TRC/IU: 93-07, Task: 0103
 ISP Photo: impact area and
 Daytona's post-impact scuffs

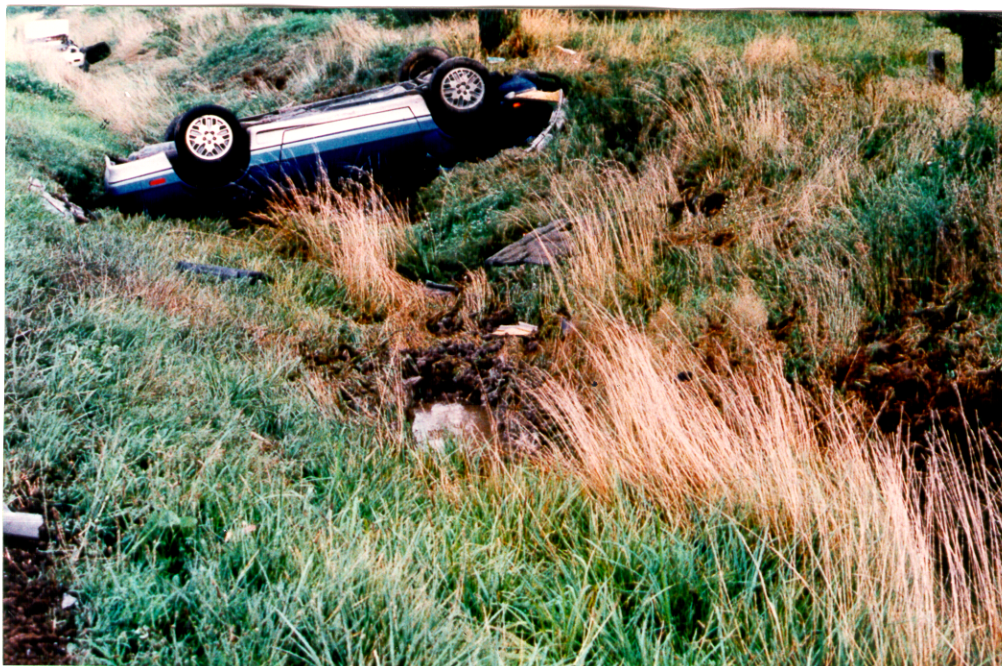
Crash (Cont'd.) dence visible in the on-scene police photographs (see Photographs #02 and #05), the ground divots in the ditch at the scene (see cells E5 and I5 in Photograph #09), and the damage on the case vehicle's right quarter panel indicates that the case vehicle rotated approximately 180 degrees counterclockwise after its initial impact. During the rotation the case vehicle departed the northwest edge of the intersection and impacted the north slope of the ditch with the right rear wheel and quarter panel (see Photograph #30). This impact was of sufficient severity to displace the rear axle to the left and push the right rear wheel inward (see Photograph #11). After impacting the ditch the case vehicle began rotating clockwise and the right front wheel gouged the bottom of the ditch (see cell E5 Photograph #09) loading the right front wheel with mud (see cells D4 and E4 in Photograph #14). The case vehicle rolled over two quarter turns with the right side leading and came to rest facing north on its top in the ditch northwest of the intersection. The evidence in the on-scene police photographs (see Photographs #07 and #21) and the ground divots at the scene indicates that vehicle #2 continued in a northwesterly direction after its initial impact and departed the northwest edge of the intersection. As vehicle #2 traveled along the south slope of the ditch, the left front wheel (see cells A6 and B6 in Photograph #25) dug into the ditch (see cell block F2-I3 in Photograph #14 and cell block A2-I3 in Photograph #15) causing vehicle #2 to rotate approximately 90 degrees counterclockwise and impact the right rear wheel into the north slope of the ditch. Exactly what happened next is not clear; however, the damage on vehicle #2's right quarter panel (see Photographs #20, #22, and #24) and the visible debris (see photograph #07)--including a portion of the windshield (see cell E4 in Photograph #08) and the sun roof (see cells F2 and G2 in Photograph #20), indicates that this impact probably caused vehicle #2 to roll over four quarter turns while continuing to rotate approximately an additional 90 degrees counterclockwise. *(NOTE: the locations of the crash debris is apparently crash related since an interview with rescue personnel revealed that no vehicular components were removed from the car while extracting the driver.)* During the rollover, vehicle #2 impacted a small tree along the north slope of the ditch (see cell H4 in Photograph #08). Vehicle #2 came to rest facing east on its wheels in the ditch northwest of the intersection.

09 -- [REDACTED] 1993
 [REDACTED], Illinois
 TRC/IU: 93-07, Task: 0103
 ISP Photo: roadside divot
 and trip point for Daytona

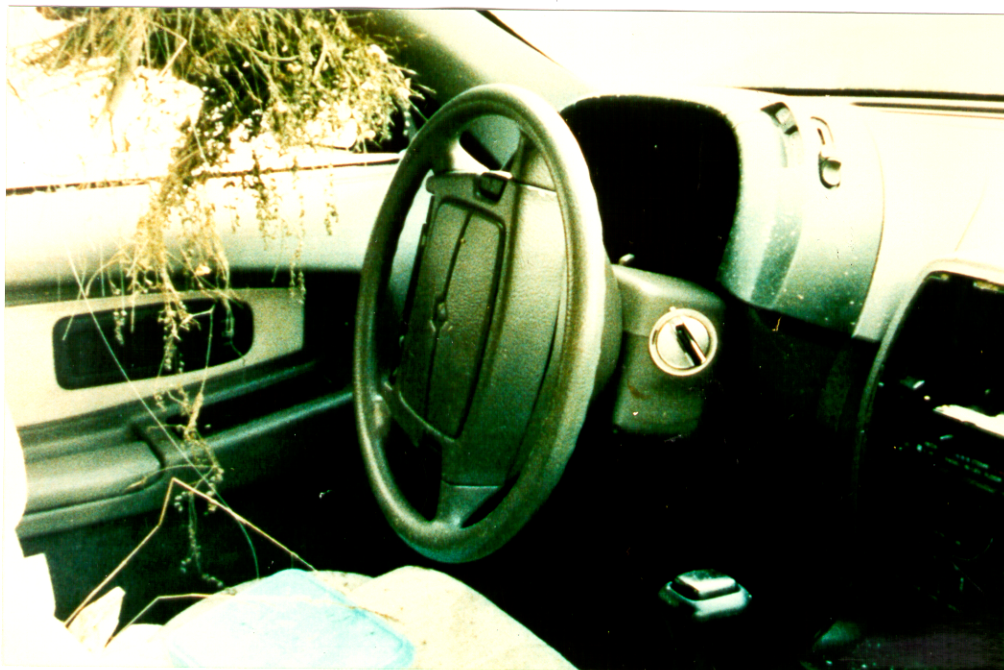
18 - [REDACTED] 1993
[REDACTED] Illinois
TRC/IU: 93-07, Task: 0103
ISP Photo: Daytona steering
wheel & nondeployed air bag

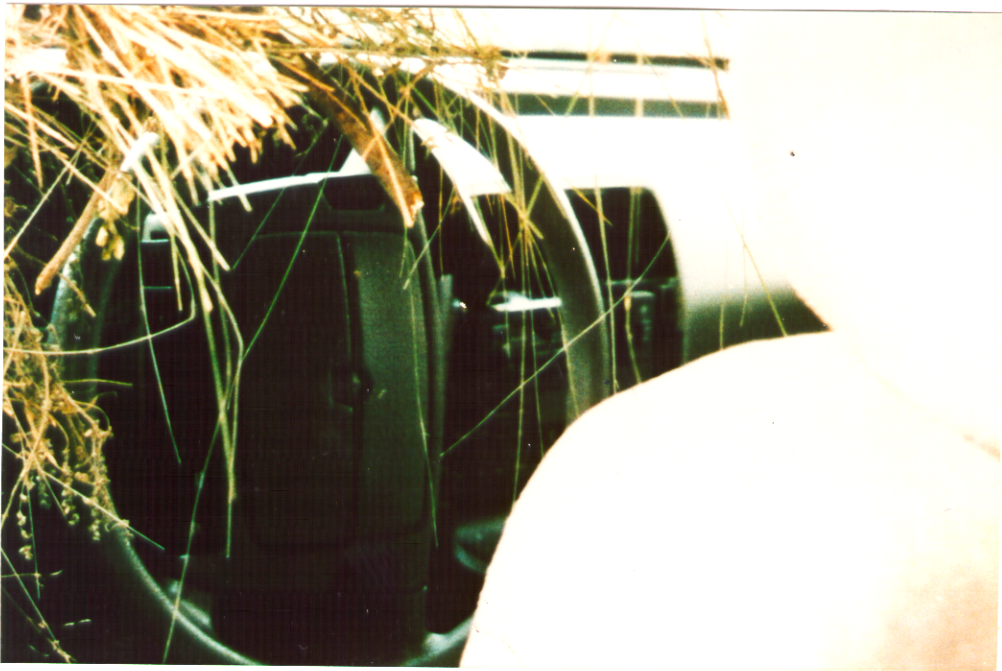
19 -- [REDACTED] 1993
 [REDACTED] Illinois
 TRC/IU: 93-07, Task: 0103
 ISP Photo: closeup of air
 bag cover through LF window

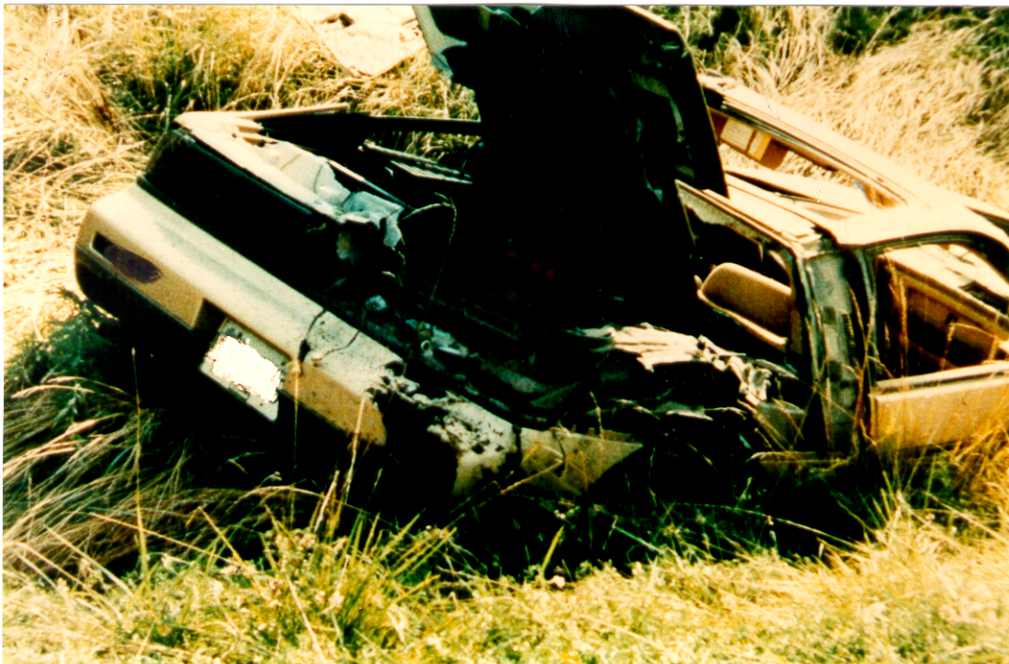
22 -- [REDACTED], 1993
 [REDACTED] Illinois
 TRC/IU: 93-07, Task: 0103
 ISP Photo: closeup of Fiero
 right-rear damage

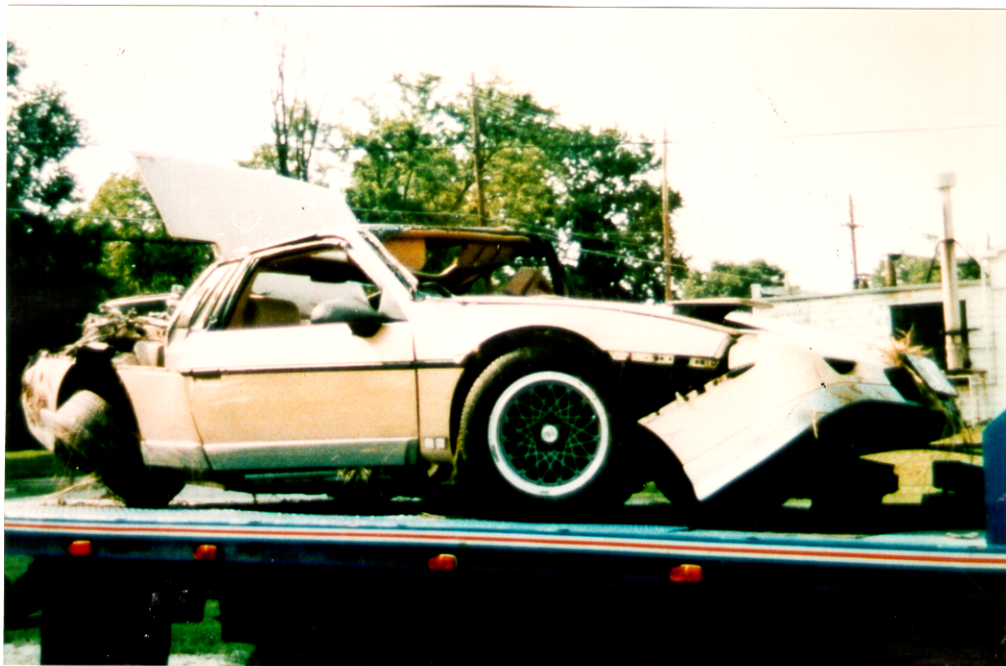
24 -- [REDACTED] 1993
 [REDACTED] Illinois
 TRC/IU: 93-07, Task: 0103
 ISP Photo: Fiero's right
 side damage

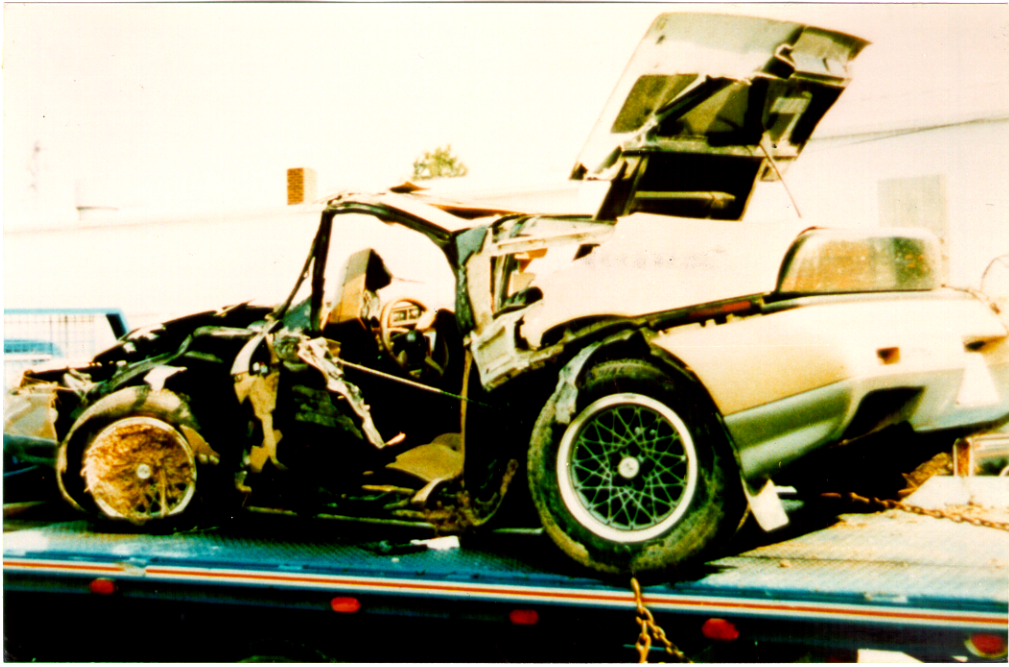
25 -- [REDACTED], 1993
 [REDACTED] Illinois
 TRC/IU: 93-07, Task: 0103
 ISP Photo: Fiero's left
 side damage

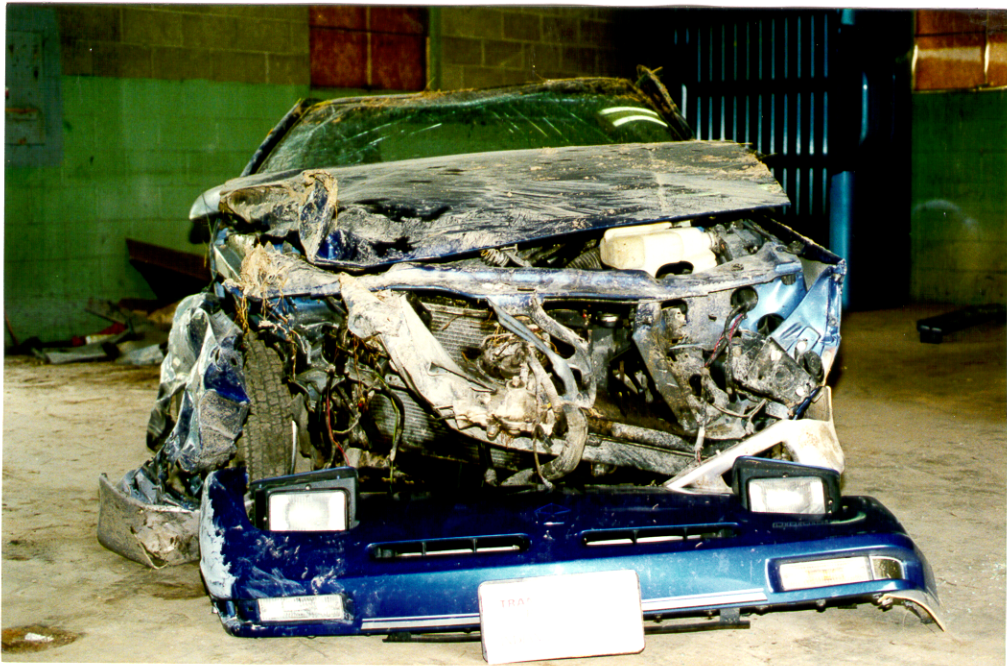
26 -- [REDACTED], 1993
 [REDACTED] Illinois
 TRC/IU: 93-07, Task: 0103
 TRC Photo: Dodge Daytona's
 front damage

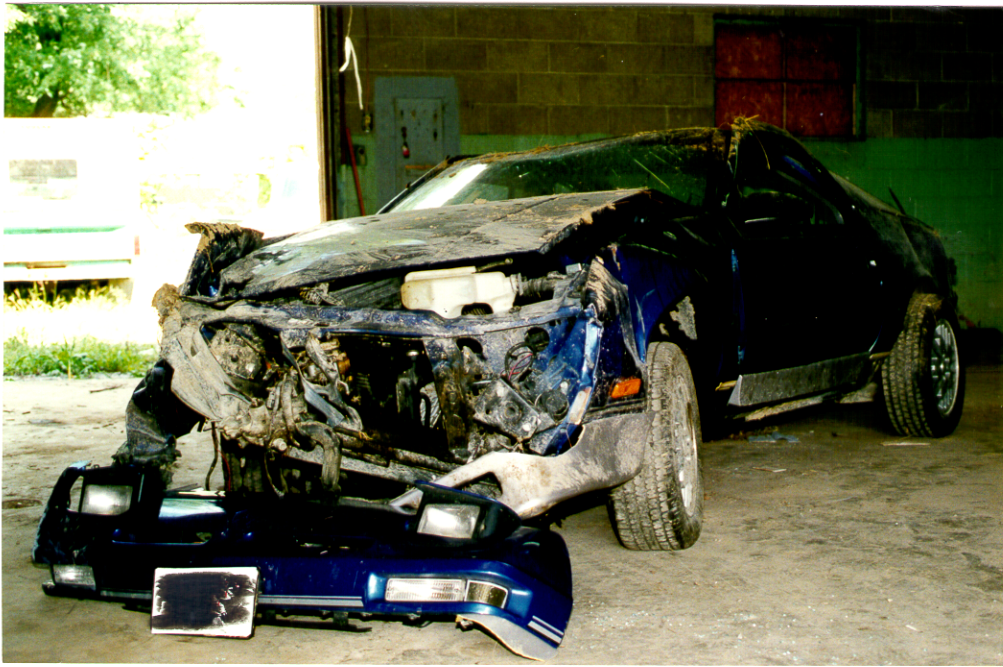
27 -- [REDACTED], 1993
[REDACTED] Illinois
TRC/IU: 93-07, Task: 0103
TRC Photo: Daytona's damage
from front-left perspective

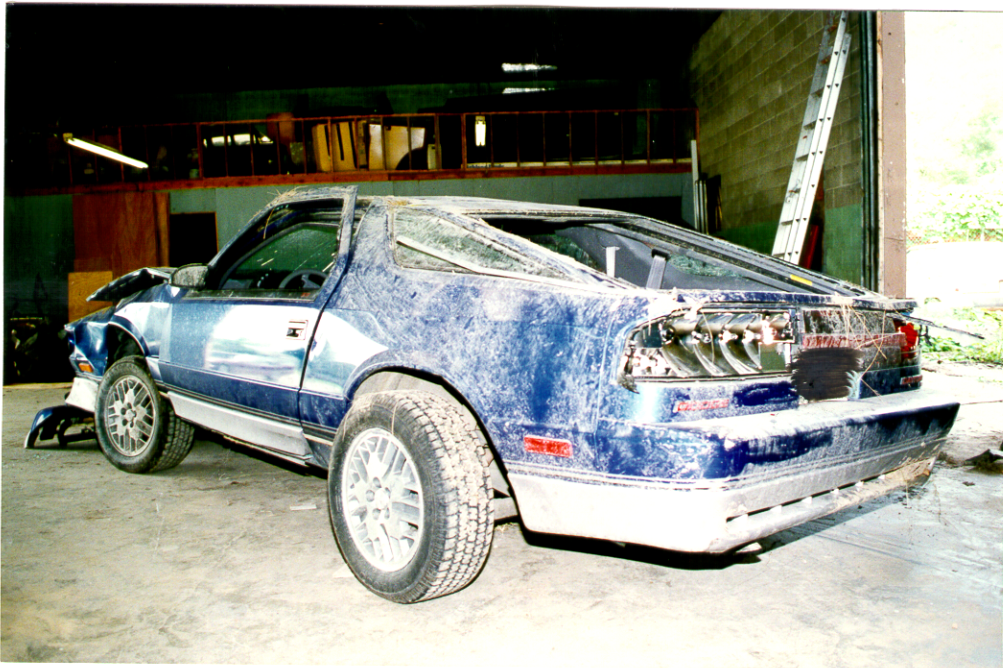
28 -- [REDACTED] 1993
[REDACTED], Illinois
TRC/IU: 93-07, Task: 0103
TRC Photo: Daytona's damage
from back-left perspective

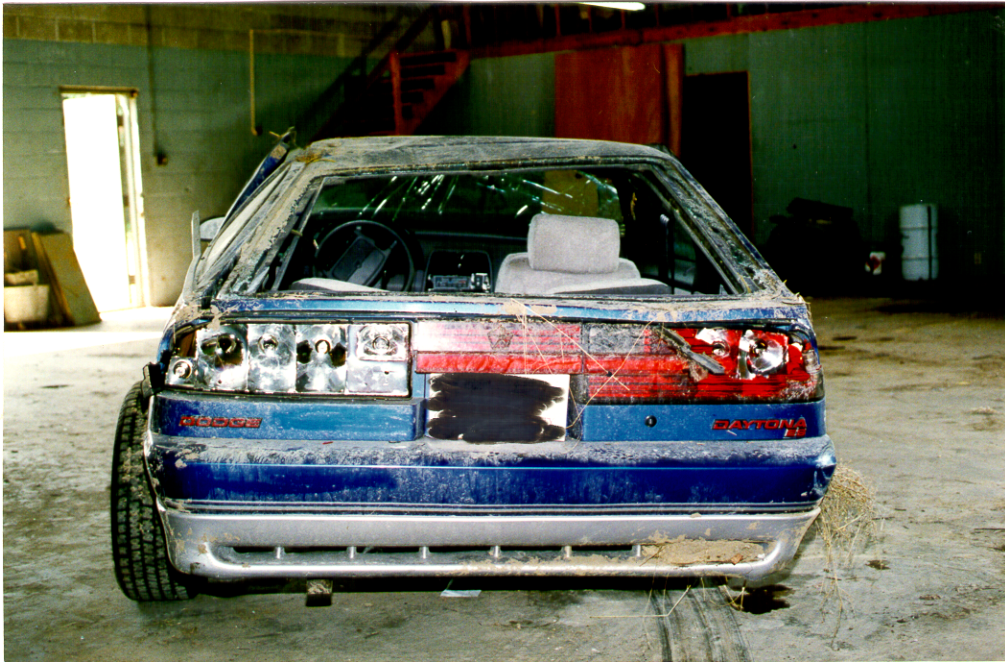
29 - [REDACTED] 1993
[REDACTED], Illinois
TRC/IU: 93-07, Task: 0103
TRC Photo: Daytona's back
damage

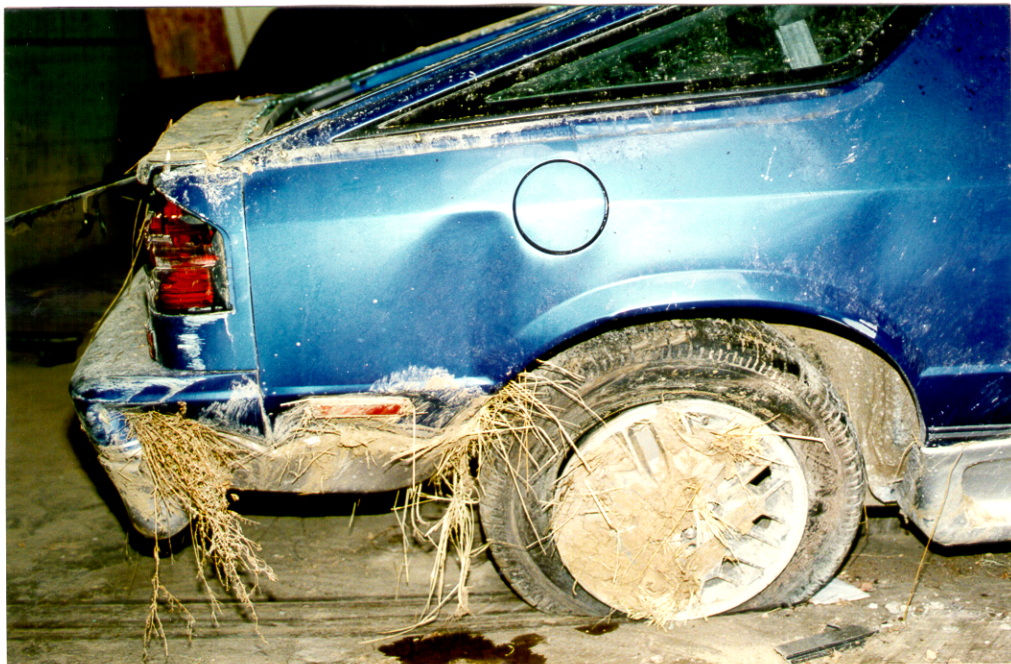
30 - [REDACTED] 1993
[REDACTED], Illinois
TRC/IU: 93-07, Task: 0103
TRC Photo: closeup damage &
grass at right-rear area

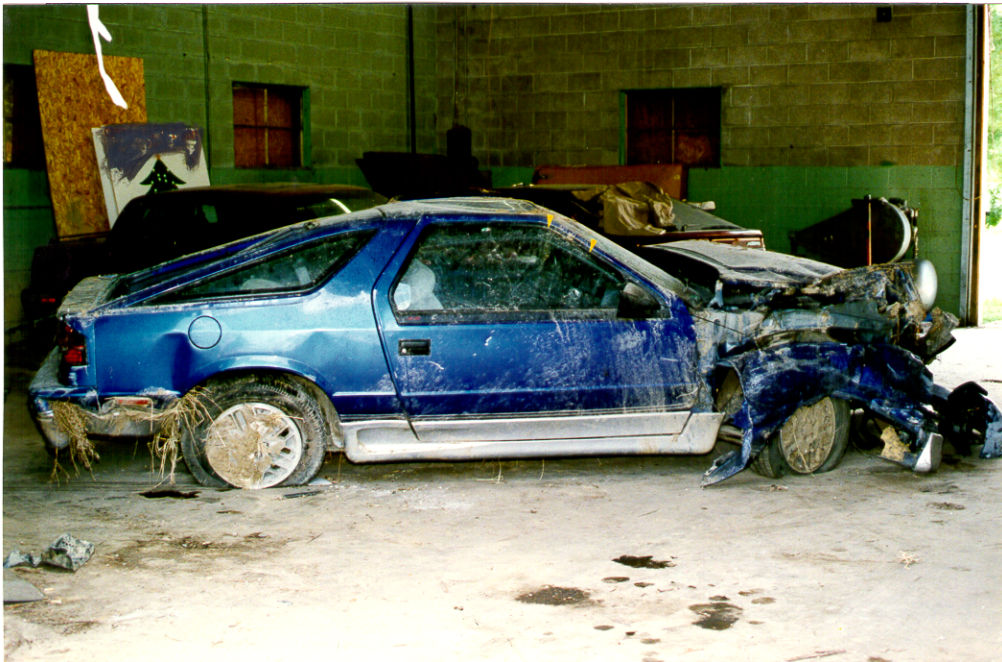
31 -- [REDACTED], 1993
 [REDACTED], Illinois
 TRC/IU: 93-07, Task: 0103
 TRC Photo: Daytona's right
 side damage

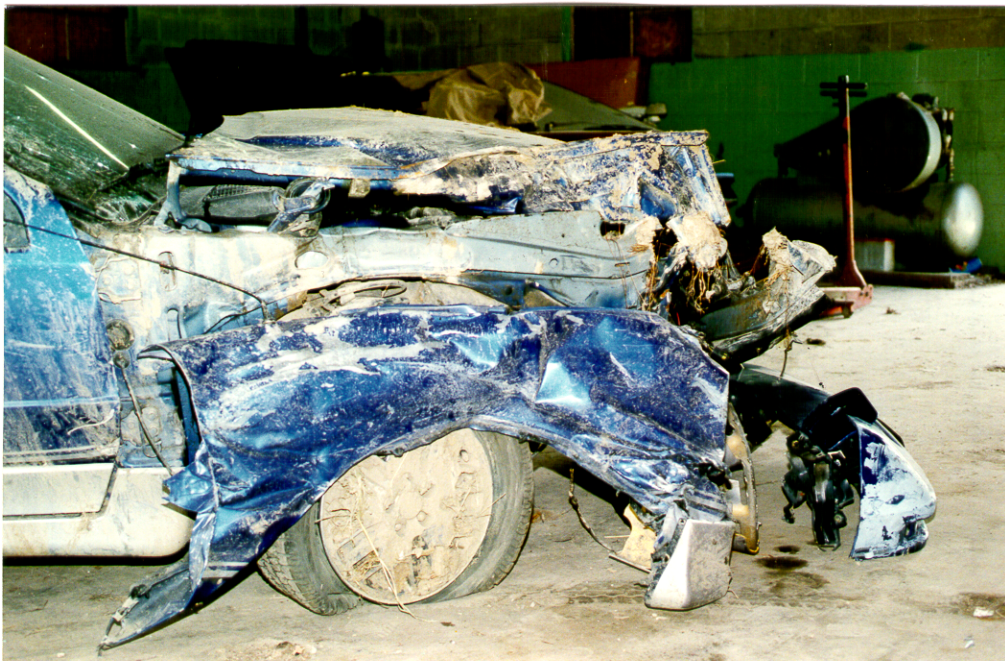
32 -- [REDACTED], 1993
 [REDACTED], Illinois
 TRC/IU: 93-07, Task: 0103
 TRC Photo: closeup damage
 at right-front area

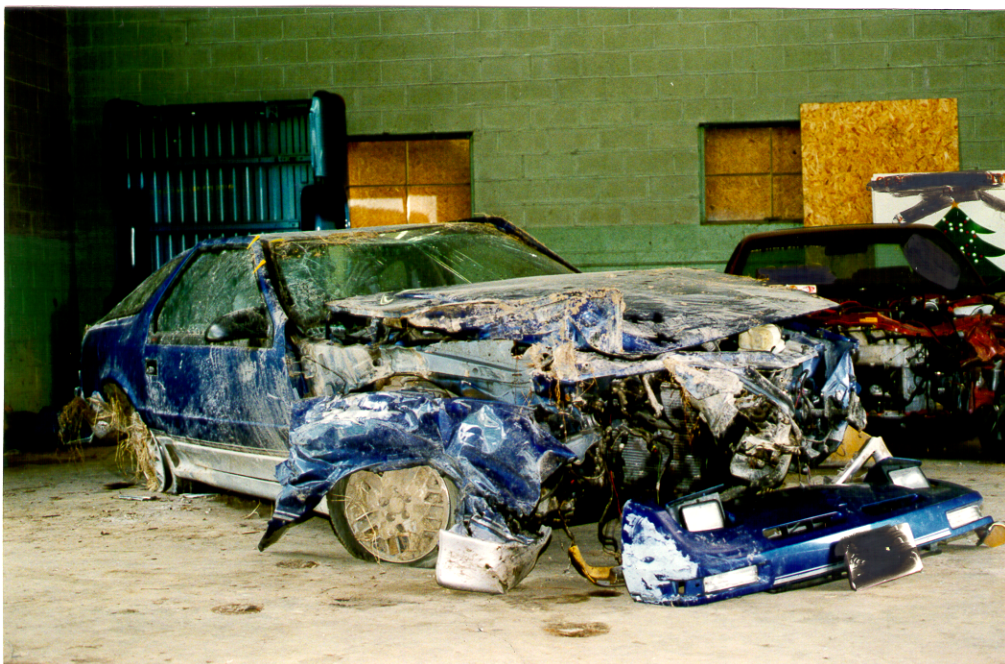
33 -- [REDACTED] 1993
 [REDACTED] Illinois
 TRC/IU: 93-07, Task: 0103
 TRC Photo: Daytona's damage
 from front-right perspective

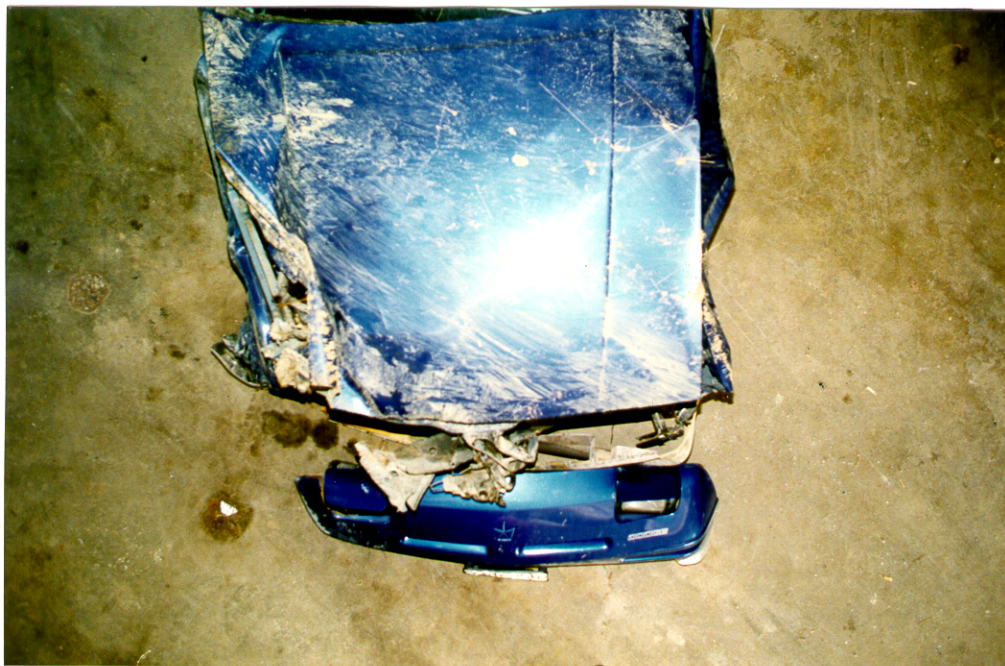
34 -- [REDACTED] 1993
 [REDACTED] Illinois
 TRC/IU: 93-07, Task: 0103
 TRC Photo: Daytona's damage
 from top-front perspective

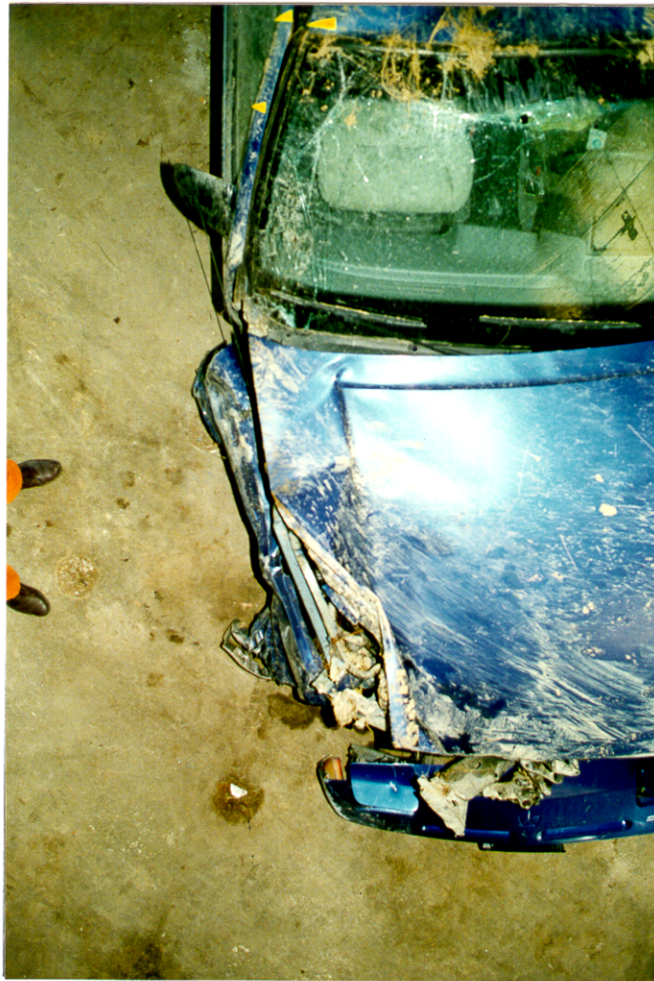
36 -- [REDACTED], 1993
[REDACTED], Illinois
TRC/IU: 93-07, Task: 0103
TRC Photo: rollover damage
of roof area from top-back

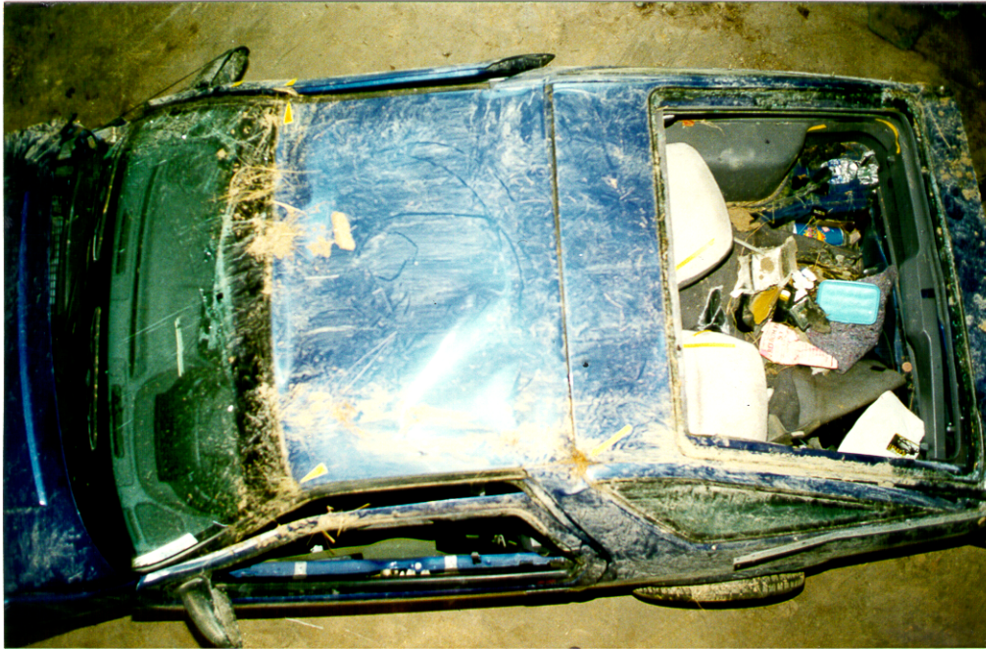
37 -- [REDACTED] 1993
[REDACTED] Illinois
TRC/IU: 93-07, Task: 0103
TRC Photo: rollover damage
from top-left perspective

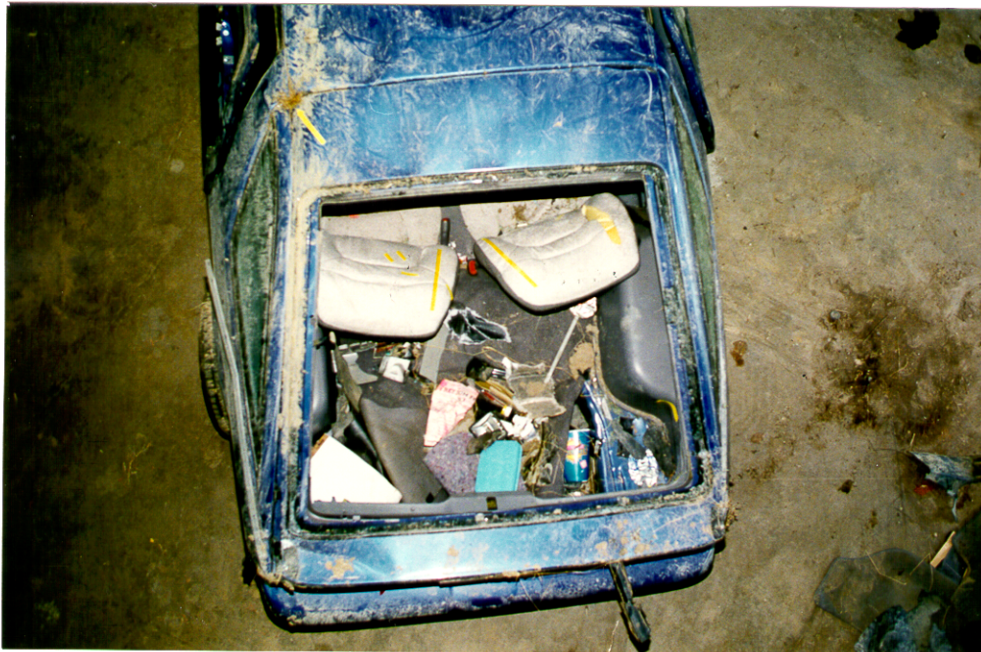
38 -- [REDACTED] 1993
[REDACTED] Illinois
TRC/IU: 93-07, Task: 0103
TRC Photo: rollover damage
& ejection path--top-back

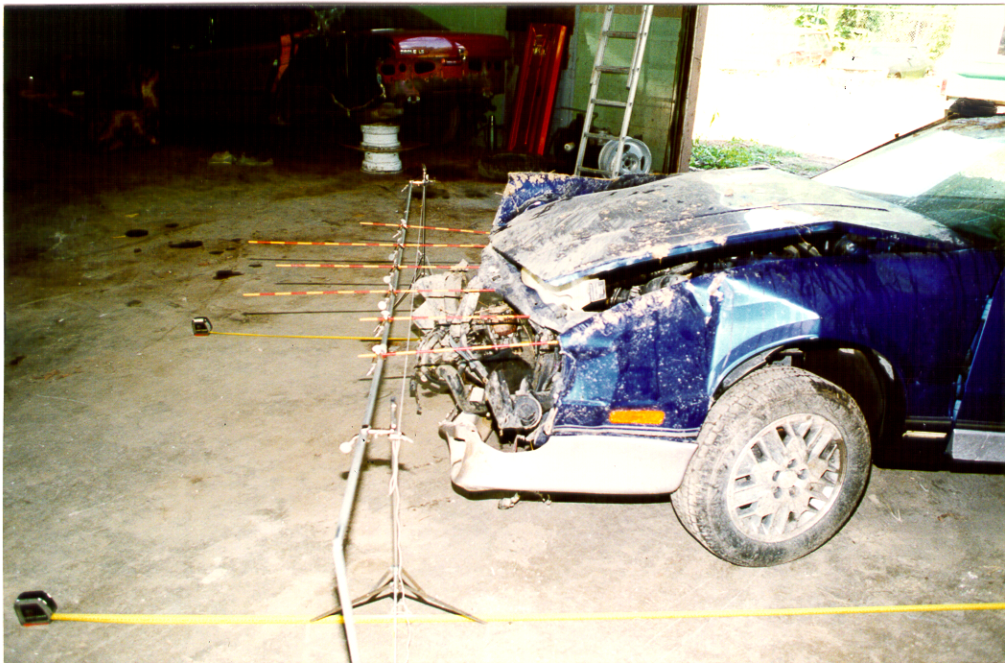
39 -- [REDACTED] 1993
 [REDACTED] Illinois
 TRC/IU: 93-07, Task: 0103
 TRC Photo: front damage and
 contour gauge from left

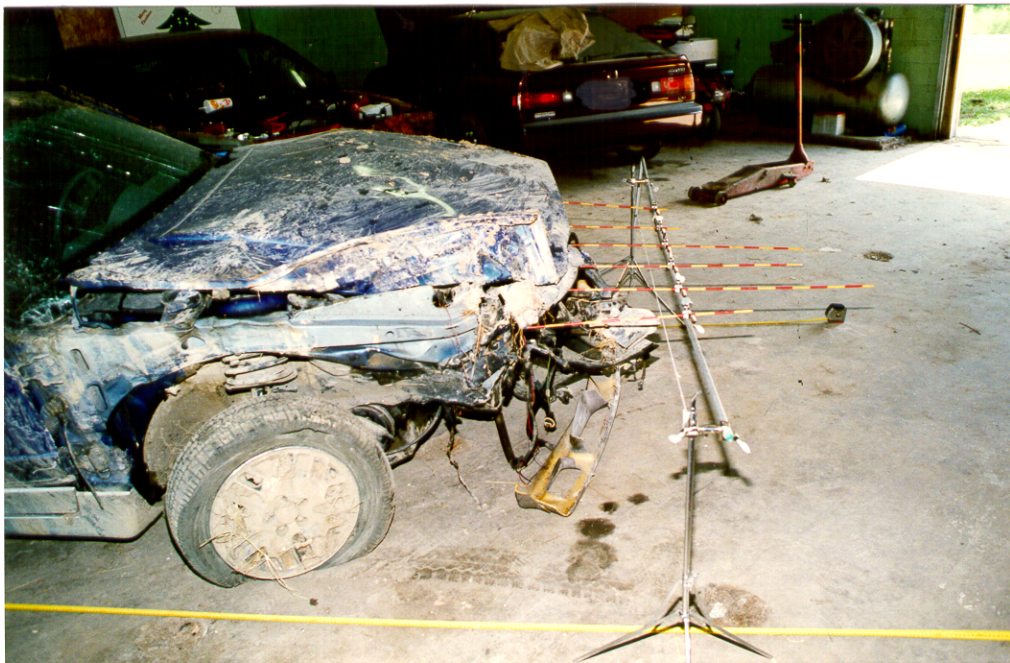
40 -- [REDACTED] 1993
 [REDACTED] Illinois
 TRC/IU: 93-07, Task: 0103
 TRC Photo: front damage and
 contour gauge from right

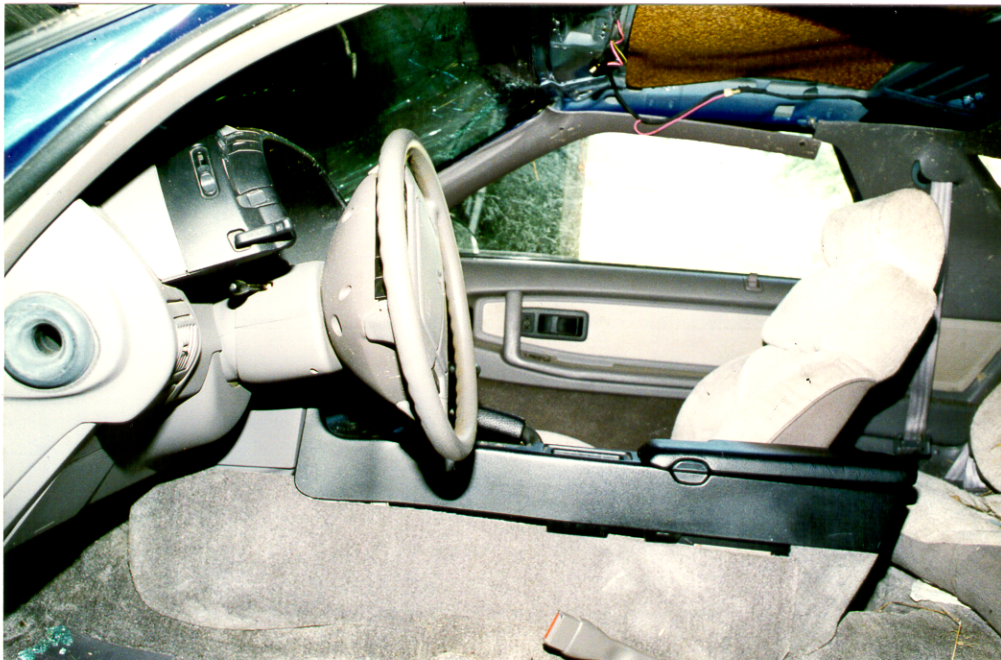
42 -- [REDACTED] 1993
 [REDACTED] Illinois
 TRC/IU: 93-07, Task: 0103
 TRC Photo: steering wheel &
 bag cover-no loading evident

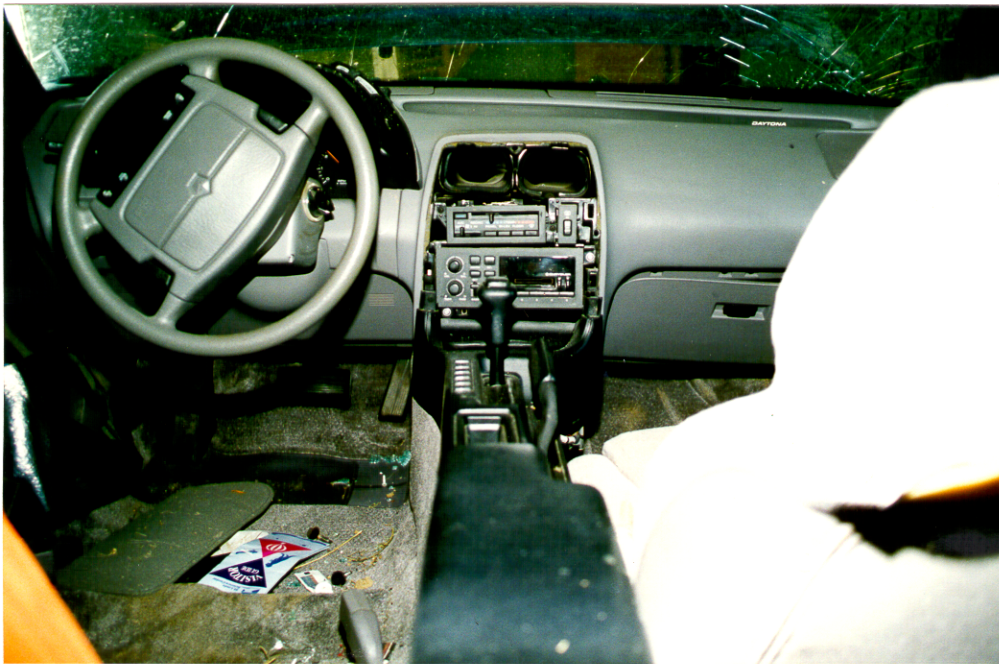
45 - [REDACTED] 1993
 [REDACTED], Illinois
 TRC/IU: 93-07, Task: 0103
 TRC Photo: center panel
 with portions missing
